Multiple-Purpose Project
Marmaton River, Kansas

Historical and Architectural Field Survey of a Portion of Fort Scott Lake Project, Bourbon County, Kansas

Contract No. DACW41-82-C-0169

Cultural Resources Report 83-8

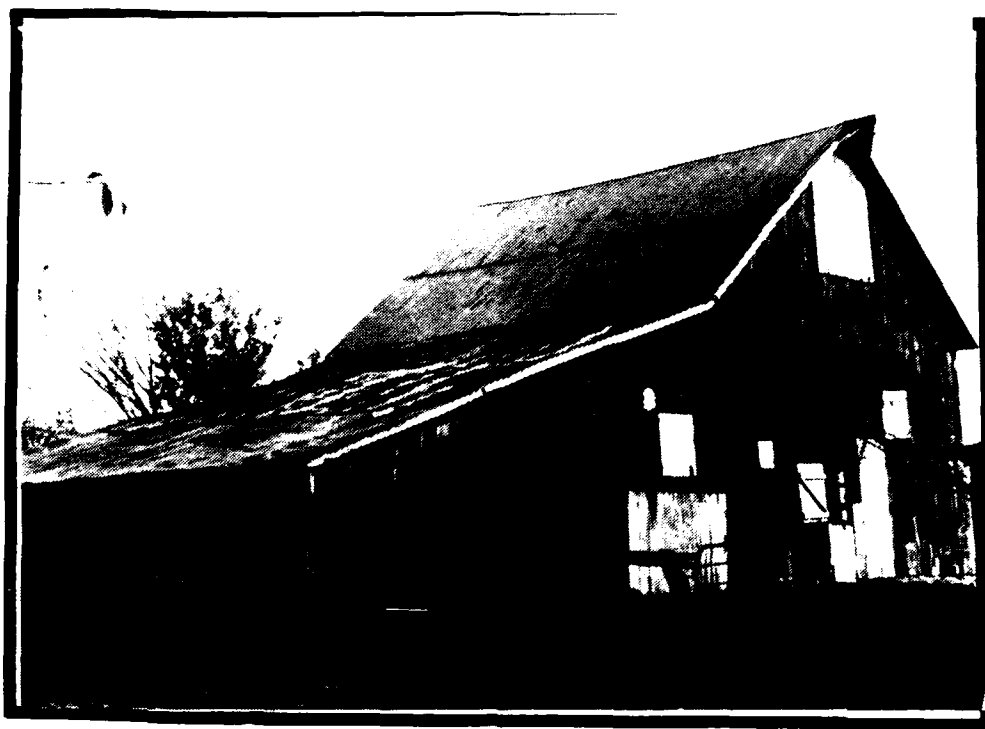
The dairy barn has a catslide roof with an unerlosed small triangle-shaped hay hood in the gable end above the main entrance on the south side (Figure 14). The barn has a ground floor and loft and its frame is constructed of handmade trusses pinned with wire nails. The exterior wall is vertical tongue and grove and is painted red with white trim on the doors and hay hood door. There are three lightening rods on the ridgeline of the barn, at the north and south ends and in the center. The original wood shingle roof has been replaced with corrugated tin. The original foundation of the barn is fieldstone with cement and is intact.

Figure 14. East elevation of barn at FN3 looking northwest. This barn is typical of the area, having a triangle-shaped hay hood and contrasting trim.

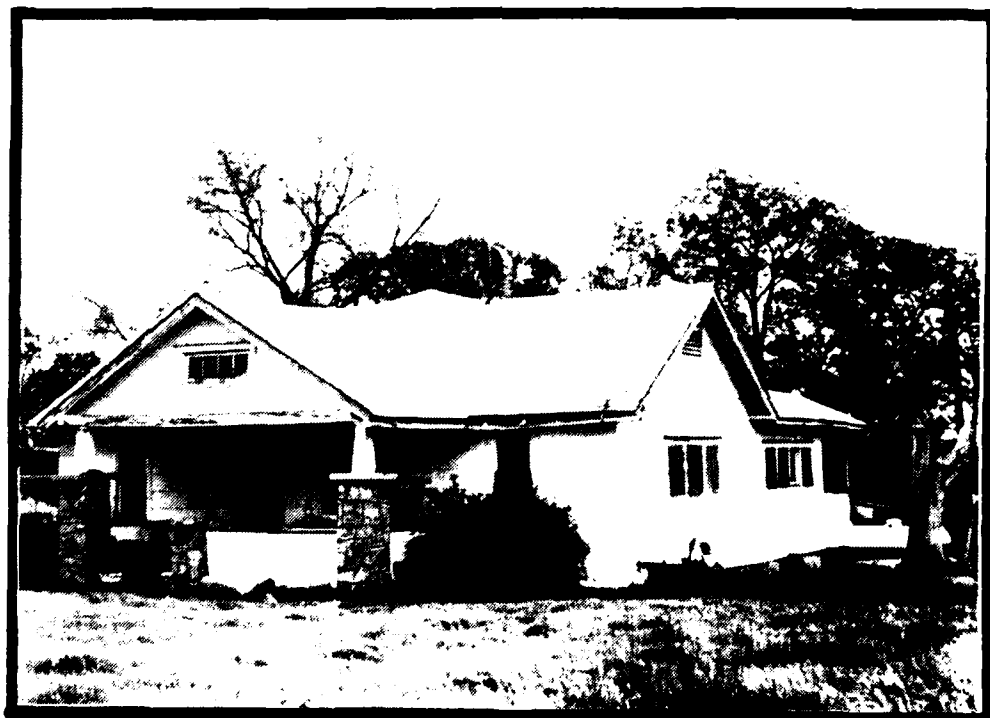
On this site there are two outbuildings and a house. One of the outbuildings appears to have been a small stable. The house is a one story, cross-gabled building (Figure 15). The plan is one variation of a planbook bungalow five-room house. The eaves are open and the roof is covered with asphalt shingles. The windows on the west side are single three-over-one sash windows; the other windows are single pane and vary in height and width. The house has been covered with asbestos siding, and the original siding material could not be determined. The wall foundation of the house is native stone with concrete mortar. There is a partial front porch with a blind wall and concrete floor. The porch supports have native-stone bases and short tapered square wood posts.

Figure 15. West elevation of house at FN4 looking east-northeast, this is a planbook house with cross-gables and partial front porch.

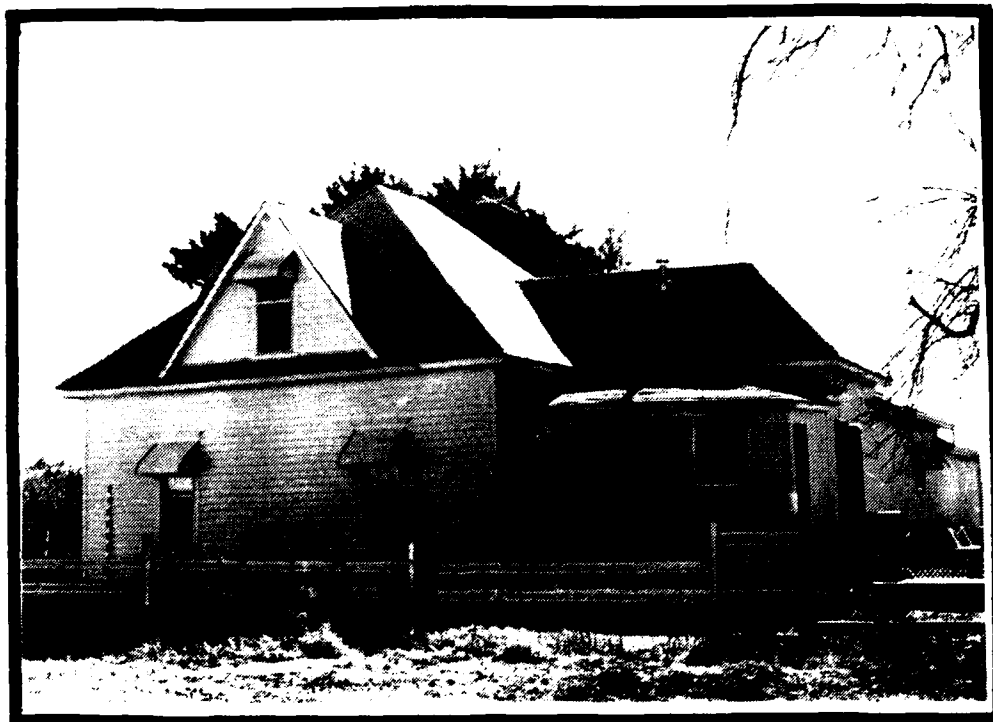
Figure 17. North elevation of house FN6 looking southeast. Originally a cubically-shaped house, several additions have been made on the west side.

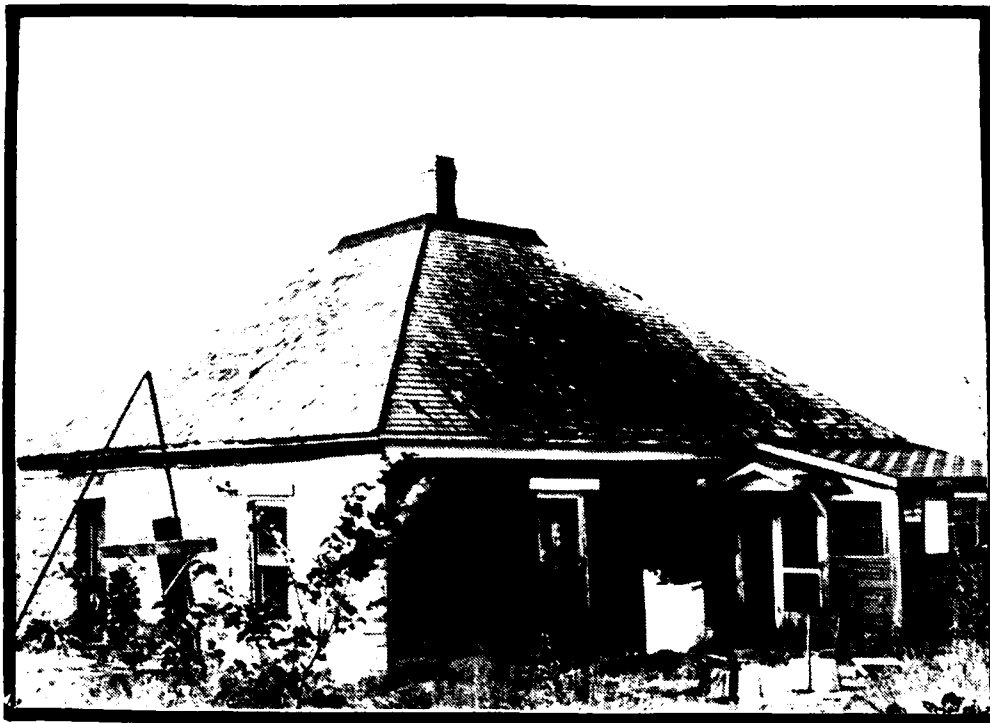
On this site there are three outbuildings, a cellar, a house, a corral, and a well house. The house (Figures 23, 24, and 25) is a two-story, six-room (four-over-two) banked house with a truncated pyramidal roof. The house is constructed of coursed ashlar stone quarried in the nearby Bandera Quarry. The lintels above the windows and doors are plain flagstone and window sills and door thresholds are lug flagstone. Windows are one-over-one sash. The windows on the south are double-wide windows on both the first and second story; the remaining windows are single. The house has

Figure 23. North elevation of FN10 looking southwest. Detail of stone construction, roof material and configuration and small closed-in porch addition on the northwest corner, shown here in the right foreground.

the original wood shingles and brick chimney flue. There used to be a two-story wood porch on the east side, but only parts of the porch flooring remain. A red brick corbelled chimney flue rises out of the center of the roof. The eaves are boxed. Only one alteration has been made, to the northwest corner of the house. The addition appears to have been an open porch that was later closed in. The root cellar is adjacent to the east end of the house and is banked also.

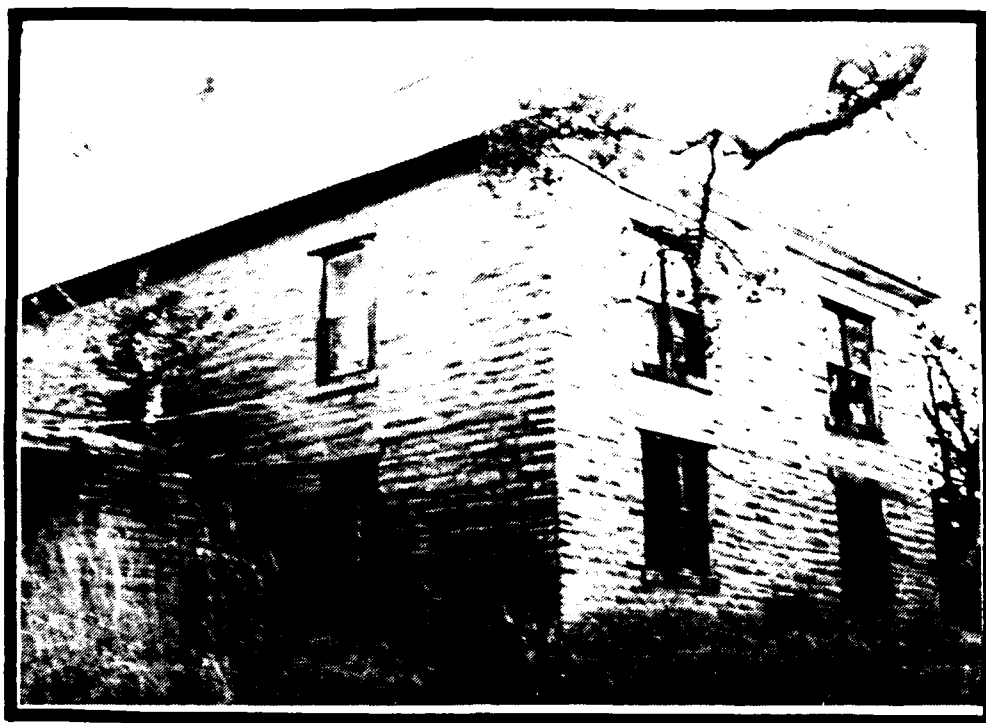
Figure 25. South and west elevations of house at FN10 looking northeast. Window detail of flagstone lintels and sills. Banked root cellar with stairs between cellar and house may be at bottom left of this photograph.

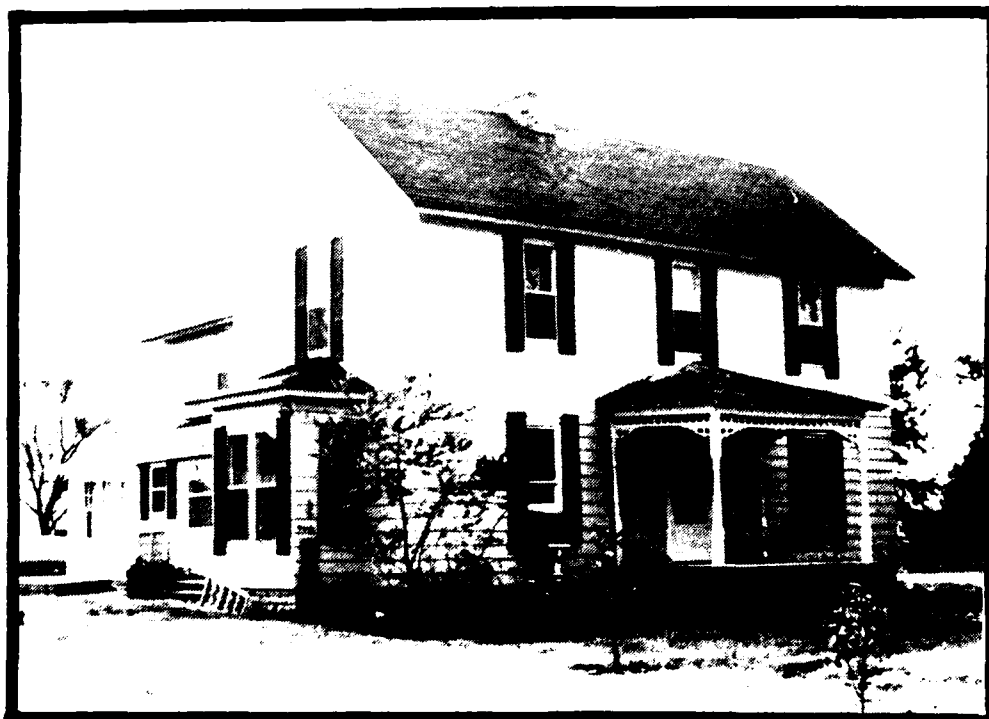
Figure 26. North elevation of house at FN11 looking southwest. Two-story tee-house with central chimney.

On this site there are two outbuildings, a house, barn, cellar and well. The house is a two-story, eight-room T-plan building with a partial basement (Figure 26). The roof is cross-gable with boxed eaves and asphalt shingles. An addition has been built on the east side and the house is in the process of being re-sided with 9-in aluminum siding (original siding was weatherboard). Greek Revival lintels decorate the windows and doors. The windows are single units with one-over-one sashes, except for the bay window on the northeast corner, which has a double unit. The windows on the east side of the addition vary in height and size. The original stone wall foundation is intact, except on the front porch where it has been replaced with concrete. The original character of the porch has not been altered. The porch supports are turned posts and have decorative lath brackets and cornice work. The eave of the porch roof has a dentilled effect from the exposed square cut rafters. The fenestration of the house, with its strong vertical elements, gives the house a Gothic Revival flavor, but the facade and plan are that of the two-story traditional central-hall house.

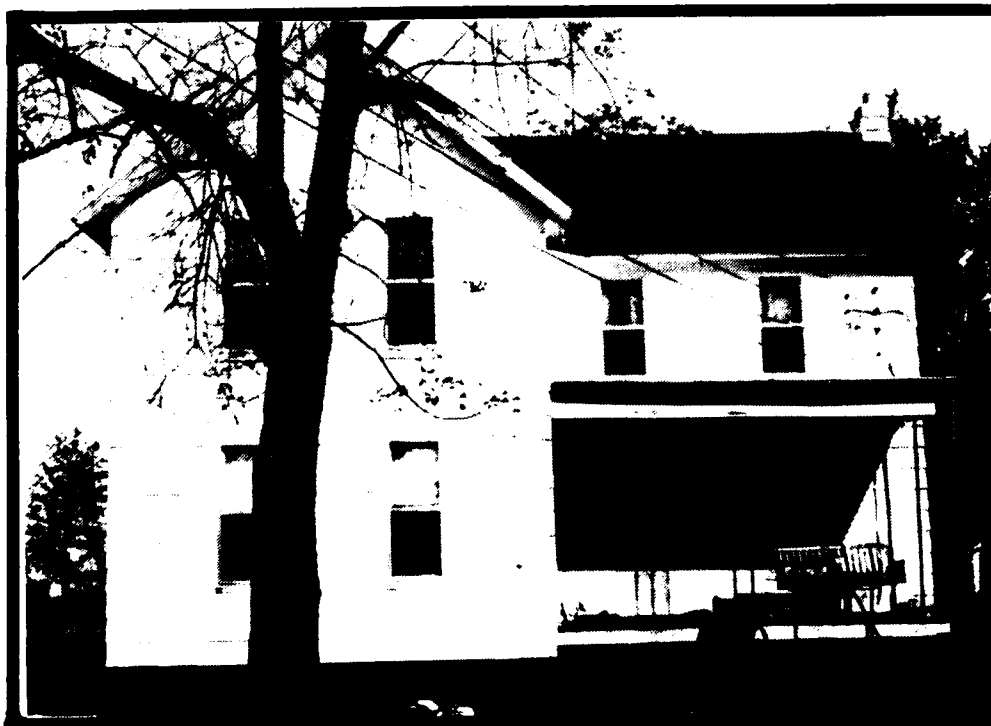
Figure 33. South elevation of house at FN17 looking north. L-shaped addition built onto the south side of the original stone house, now connected to the newer house.

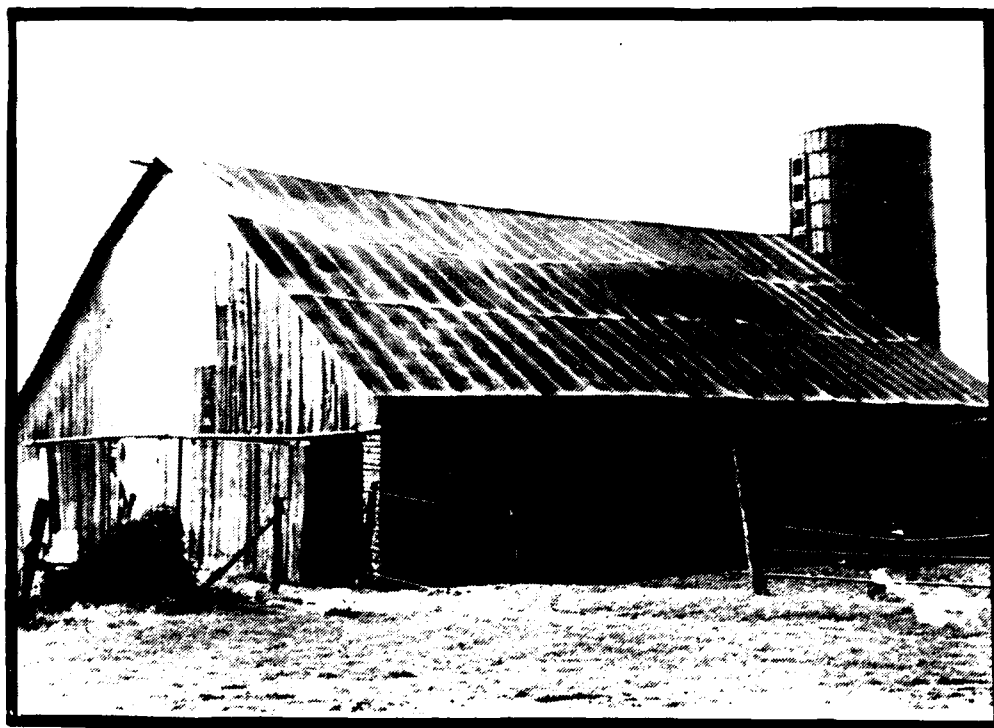
The dairy barn appears to have been built during the same period as the stone house. The barn has a corrugated tin roof, original material unknown. The interior construction was not ascertainable; however, it does have a ground floor and loft. The exterior walls are made of two materials (Figure 34): the north wall is entirely constructed of coursed unmortared limestone (the same stone used in the house), and the remaining three walls are vertical butted boards. The wood originally was painted red but has chipped and faded, leaving the wood surface bare. The barn has a hay door but no hay hood. There is a silo at the southwest corner of the barn; constructed of concrete, it is not contemporary with the barn. The barn does not have a foundation.

Figure 34. North elevation of barn at FN17 looking southwest. Board and batten barn with a native stone wall on the north.

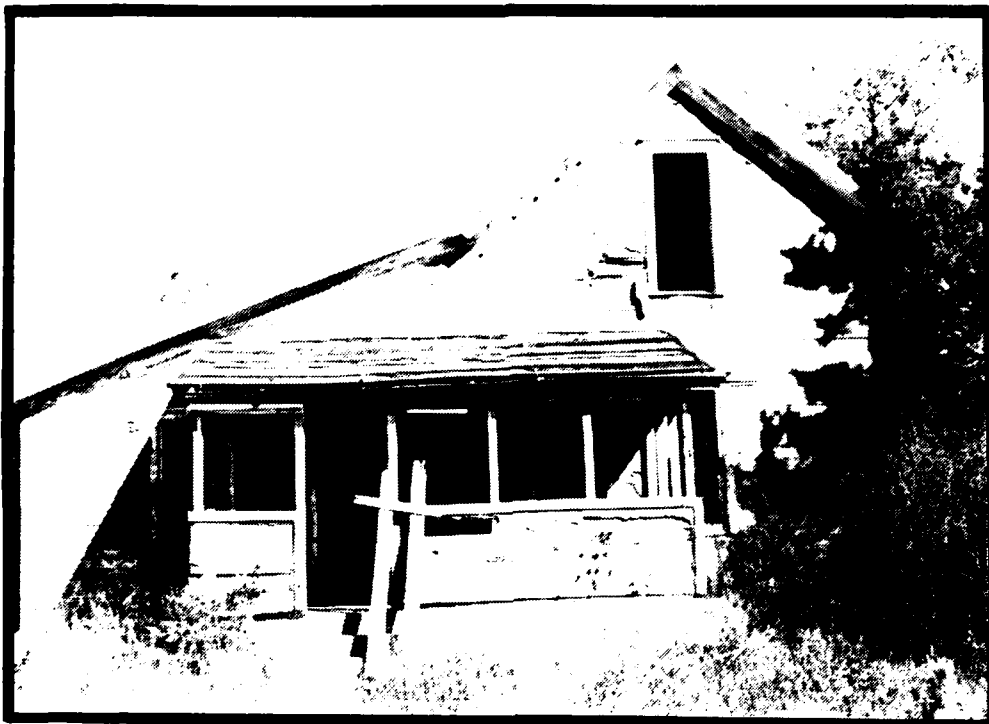
roof line denotes a two-room, one-story addition (Figure 36). The eaves on the addition and the original house are boxed. The original siding was weatherboard and has been covered with brick-patterned composite shingling. A semi-enclosed side porch was added at about the same time as the addition. Windows are of two kinds: two-over-two sash and four-over-four sash. Most of the windows have been broken out and only their casings remain. Window and door casings are plain. The exterior doors are panel with pane. The wall foundation on the house is made of concrete. The house has two chimneys, an interior brick chimney flue in the center of the ridge line, and an exterior wall chimney on the southeast side of the addition. The original house and the addition appear contemporary because of even weathering of exterior materials.

Figure 36. South elevation of house at FN20 looking north. One and one-half story house with a rear addition.

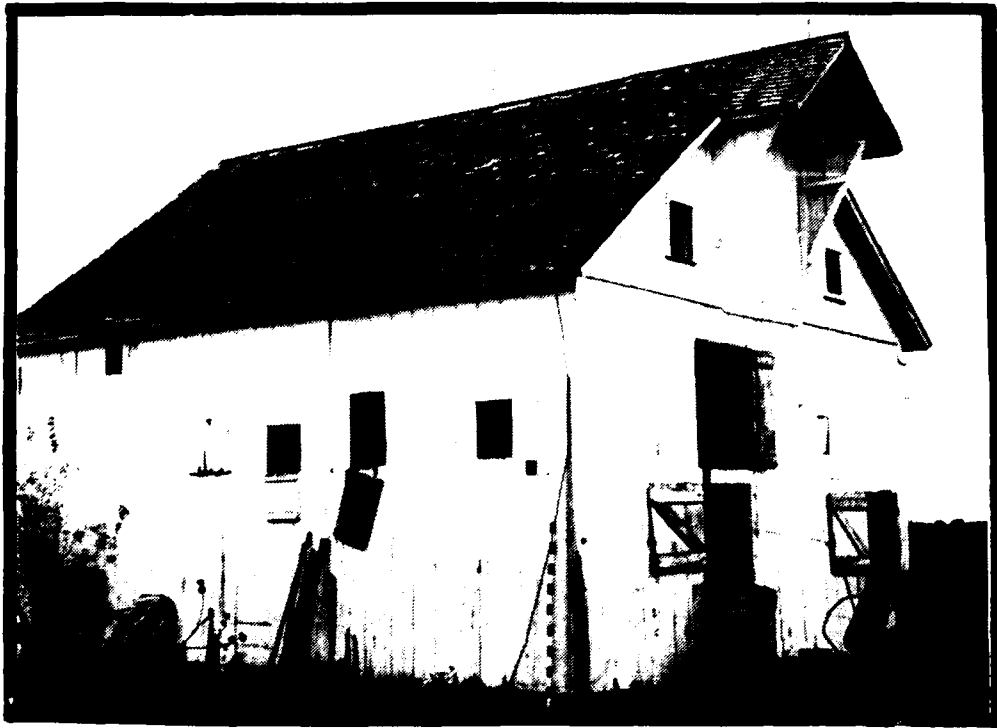
The barn is a dairy barn with a ground floor and loft. The gable roof is wood shingled and has a square-shaped hay hood in the east end. The exterior walls are constructed of vertical boards that have been painted white (Figure 38); their color was originally red. Three lightening rods are spaced along the ridge line at the interior east end, the interior west end, and the center.

Figure 38. South and east elevations of barn at FN22 looking northwest. White vertical board barn with an enclosed square-shaped hay hood.

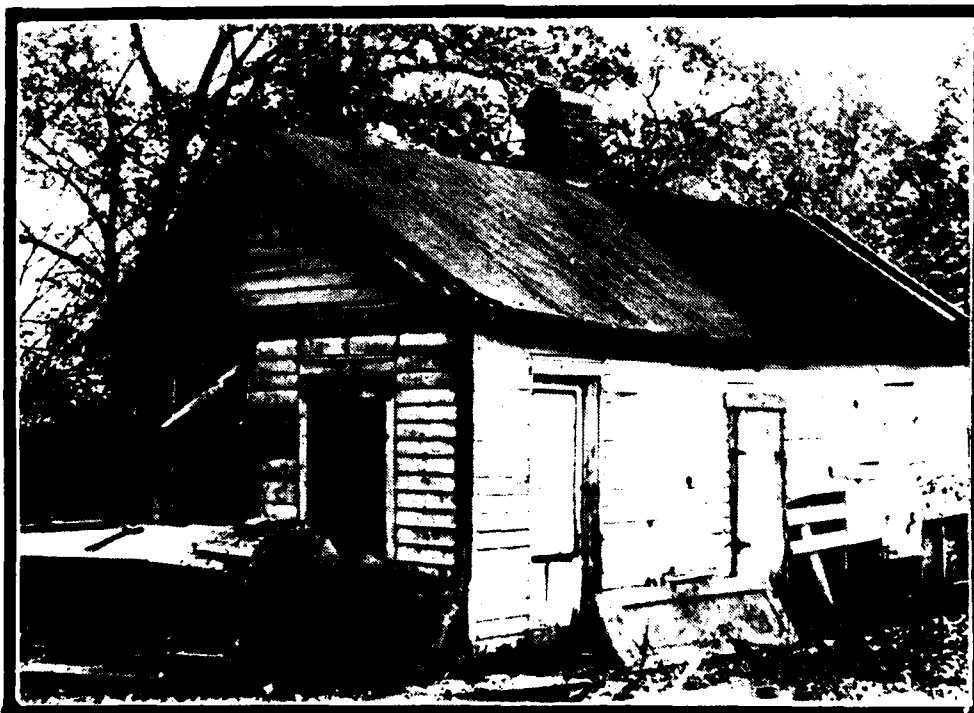
The main barn is notable for also being of partly stone construction, but it has been altered and has lost its integrity (Figure 42). The small tourist house (Figure 43) is very deteriorated.

Figure 43. North and east elevations of tourist building at FN25 looking southwest. Two-room house with central chimney.

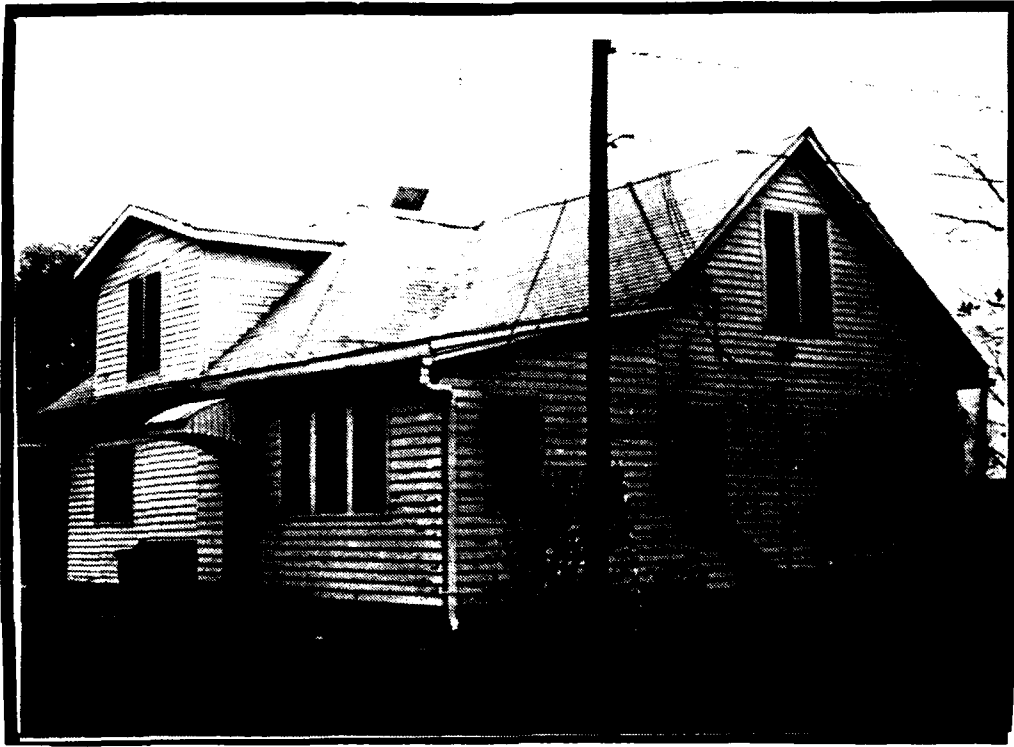
Figure 44. South and east elevations of house at FN26 looking northwest. Two-story farmhouse showing different roof angles.

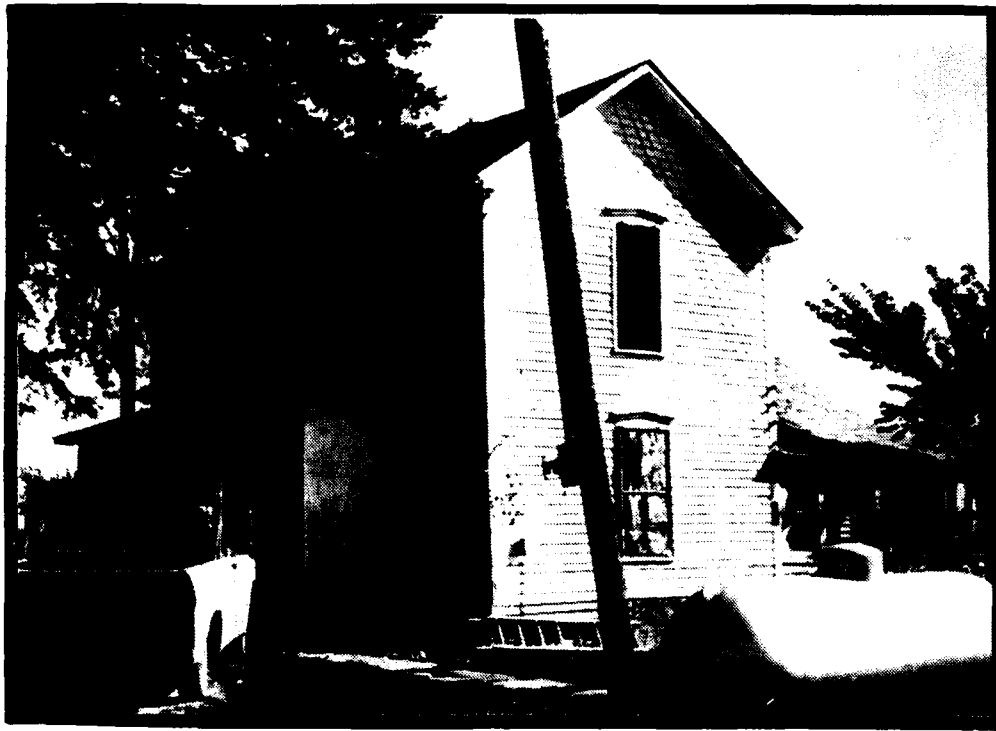
Figure 45. North and west elevations of house at FN27 looking southeast. Two-story hall and parlor house showing Greek Revival trim detail and two porch additions.

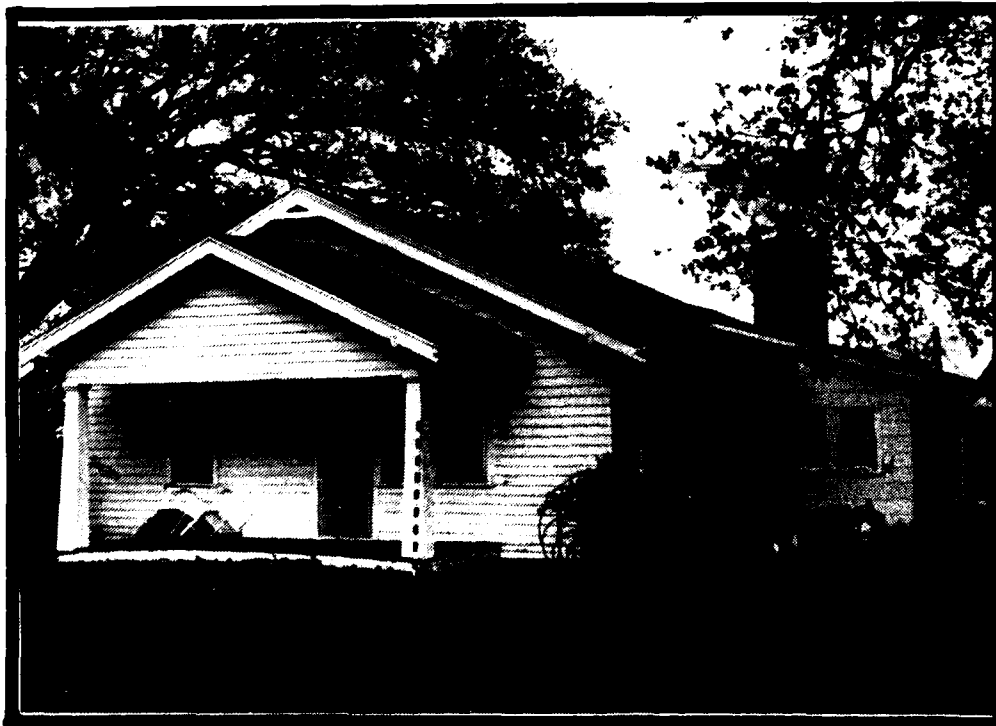
Figure 46. South elevation of house at FN28 looking northwest. Typical 1920s planbook house with an enclosed porch addition on the northeast corner.

This site consists of a house, barn, eight outbuildings, two chicken coops, a privy and cellar. This house is a one-story planbook bungalow, with two additions on the north end. The roof is asphalt shingled and has open eaves. The house is sided with white weatherboard. The windows are one-over-one sash with plain casings, and the doors are plain panel. The closed-in porch addition on the northeast corner is covered with asbestos siding (Figure 46). The house has a wall foundation with no basement.

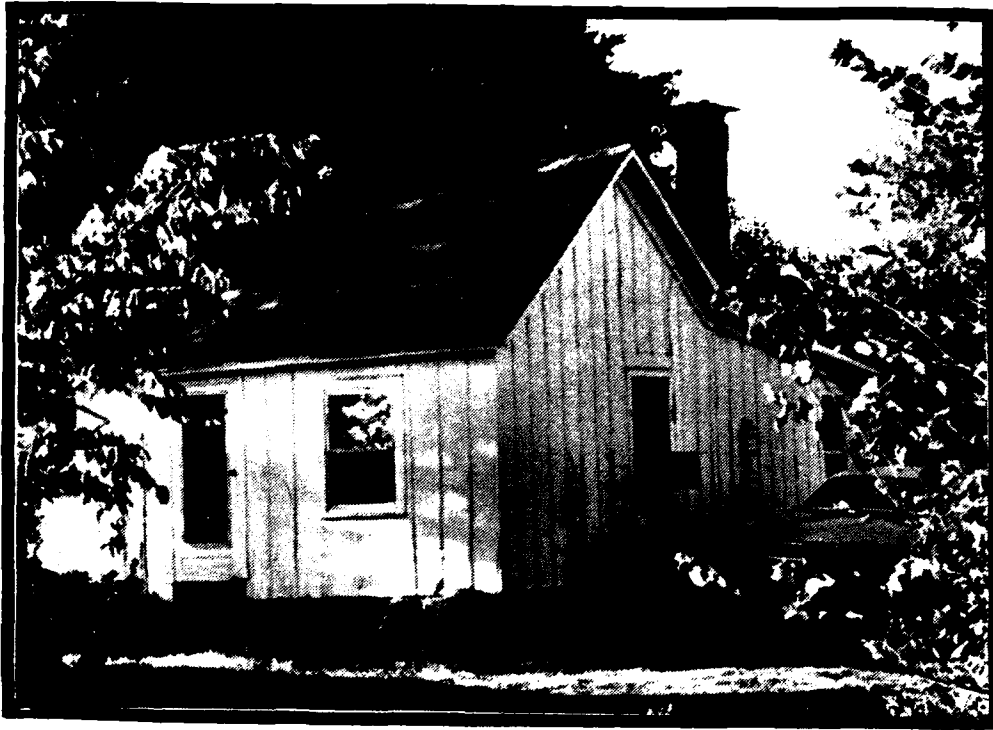
This site includes a house and barn. The house is a one-story board and batten structure (Figure 60). The barn has a triangle-shaped hay hood and a shed lean-to.

Figure 60. South and east elevations of house at FN42 looking northwest. White board and batten farmhouse.

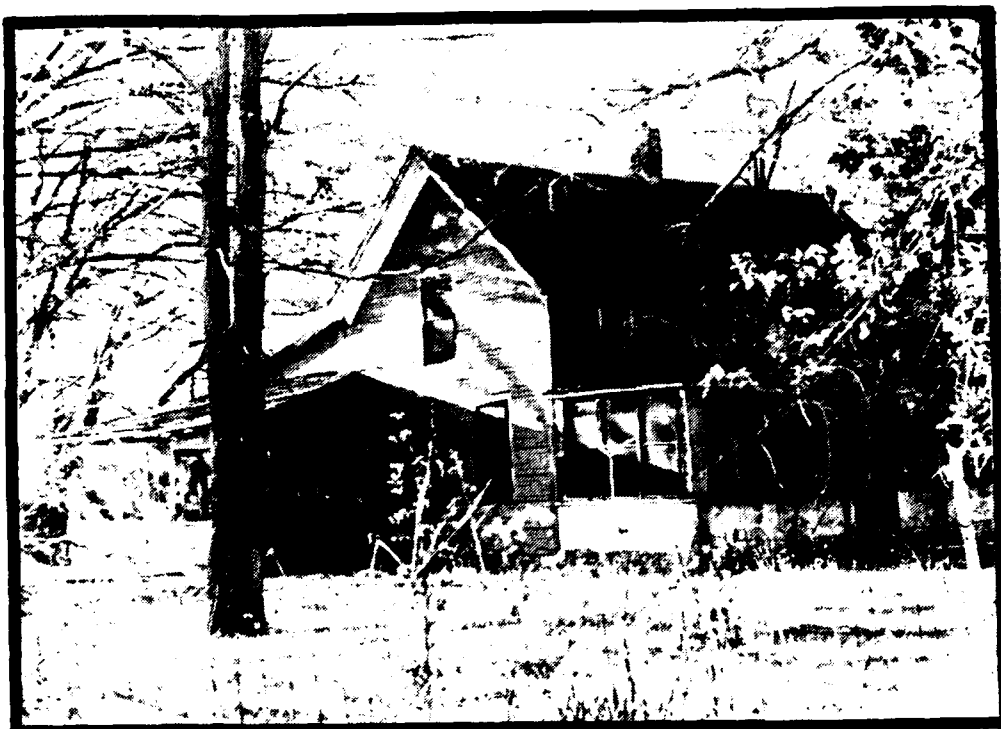
This site includes a house and garage. The house is a two-story hall-and-parlor type with two shed additions. The house is sided with brick pattern asphalt composite shingles (Figure 62).

Figure 62. South and east elevations of house at FN45 looking northwest. Two-story hall and parlor house with two closed-in porch additions.

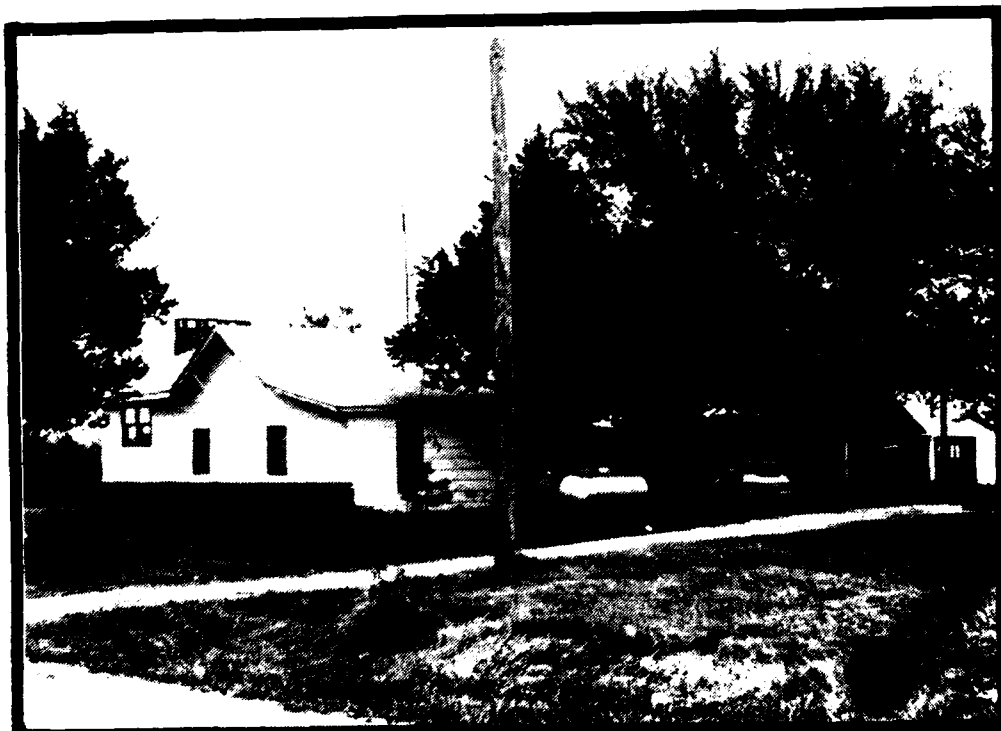
This site includes a one-story twentieth century farmhouse, and an old barn and several outbuildings (Figure 63).

Figure 63. North elevation of house at FN47 looking southeast. Modernized one-story farmhouse.

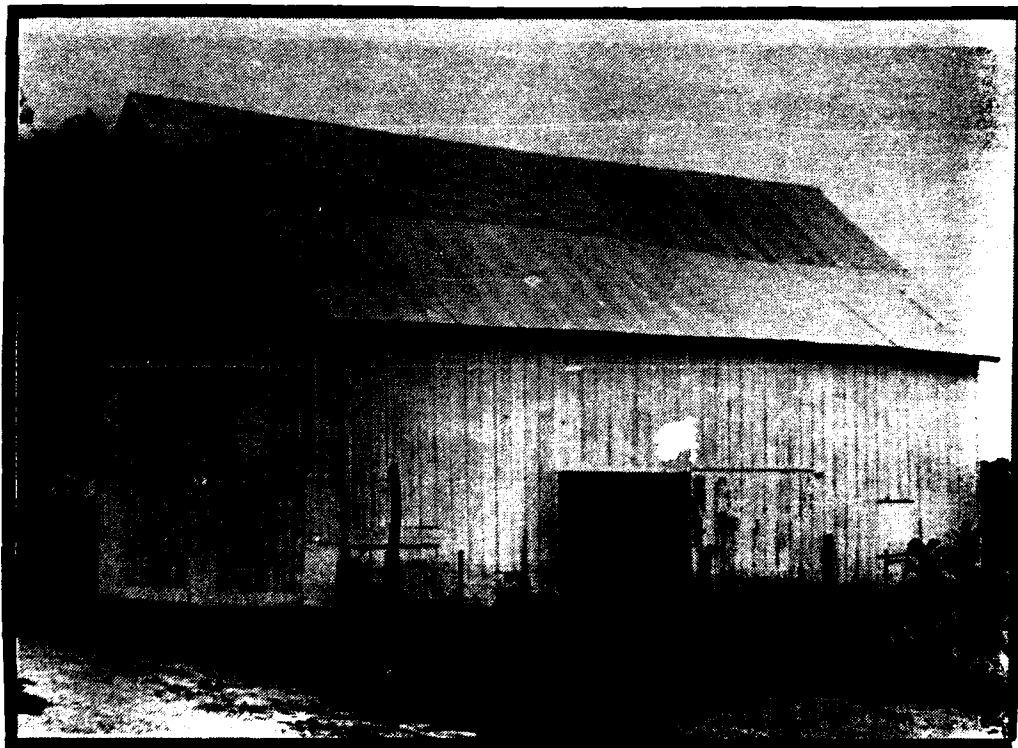
This site includes a one and one-half-story house with a hipped with gablet roof (Figure 73), and a board and batten barn with a corrugated tin roof (Figure 74).

Figure 74. East elevation of barn at FN61 looking west. English barn with enclosed square-shaped hay hood.

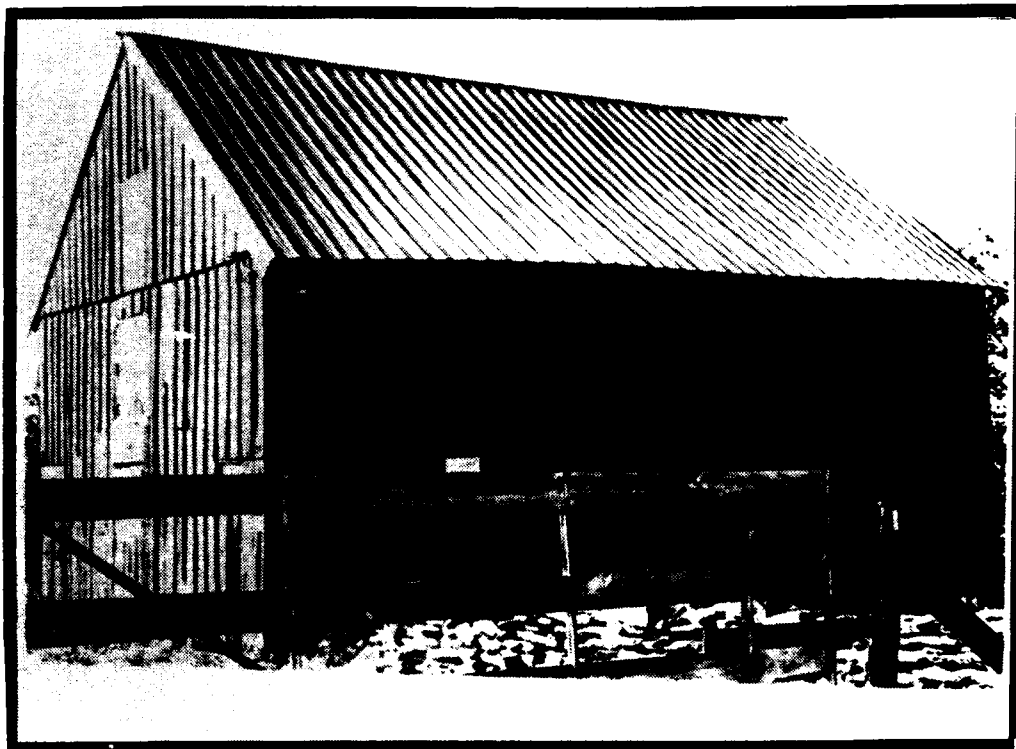
This site includes a barn and modern house. The barn is board and batten and has a corrugated tin roof (Figure 77). The barn has a fieldstone fence off one side, and a fieldstone foundation.

Figure 77. East elevation of barn at FN67 looking west. Board and batten barn.

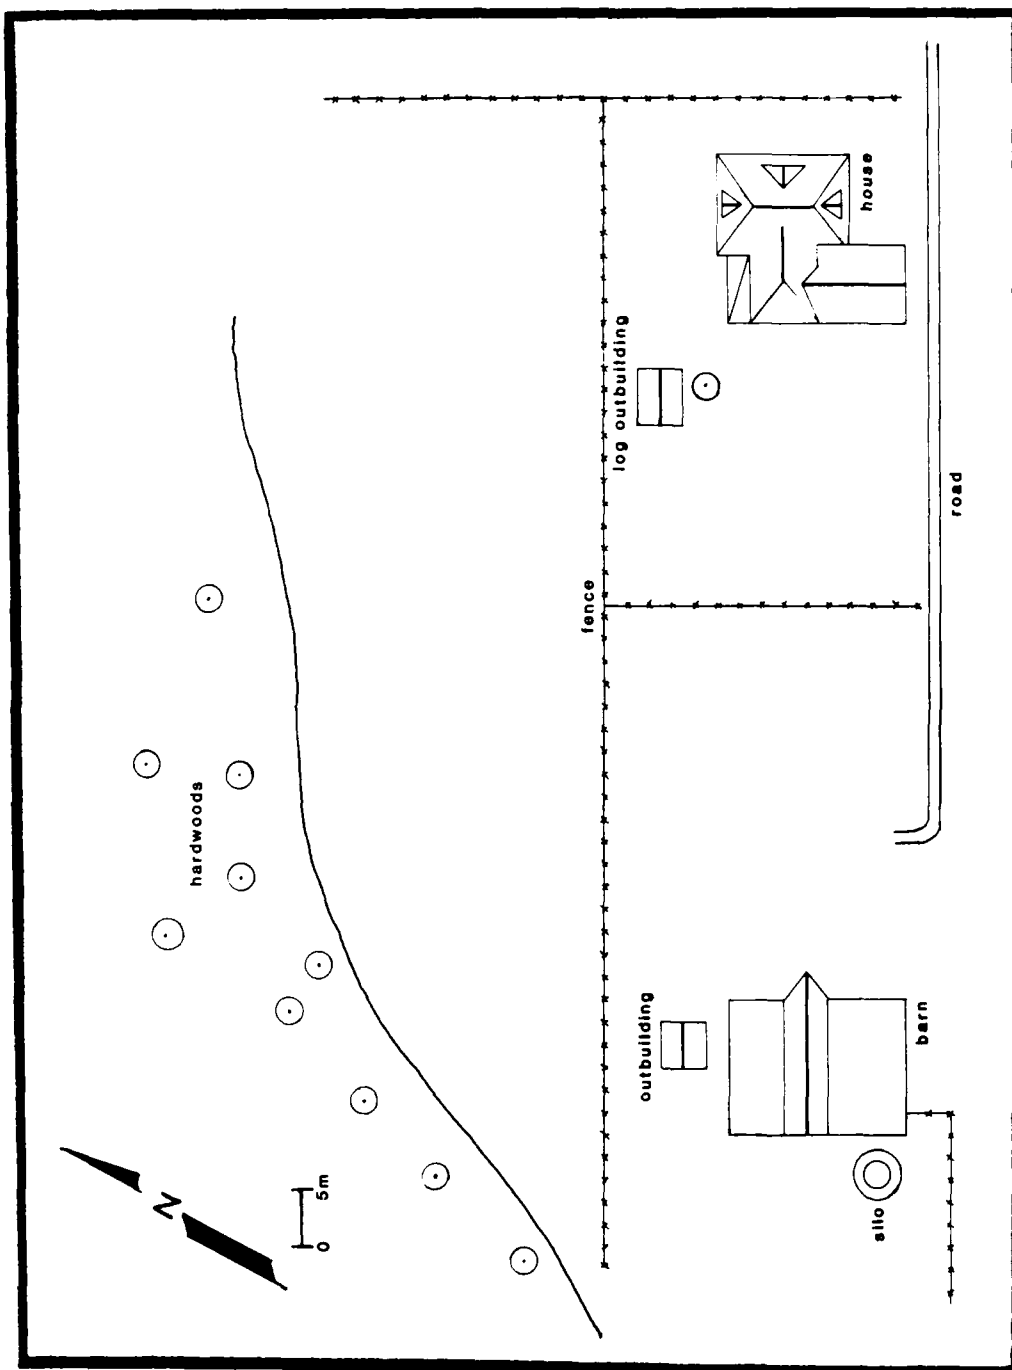
FN6 (TOD98) (11-0000-326)	Yes	Yes	The single-pen log building is the only significant structure on the site. Although in deteriorating condition, this building is one of a very few log buildings left in the Ft. Scott vicinity. Dated in local

Figure 108. Site plan, site FN6, showing location of log outbuilding.
